# BELZONA SEALS PCB LEAK

ID: 1485

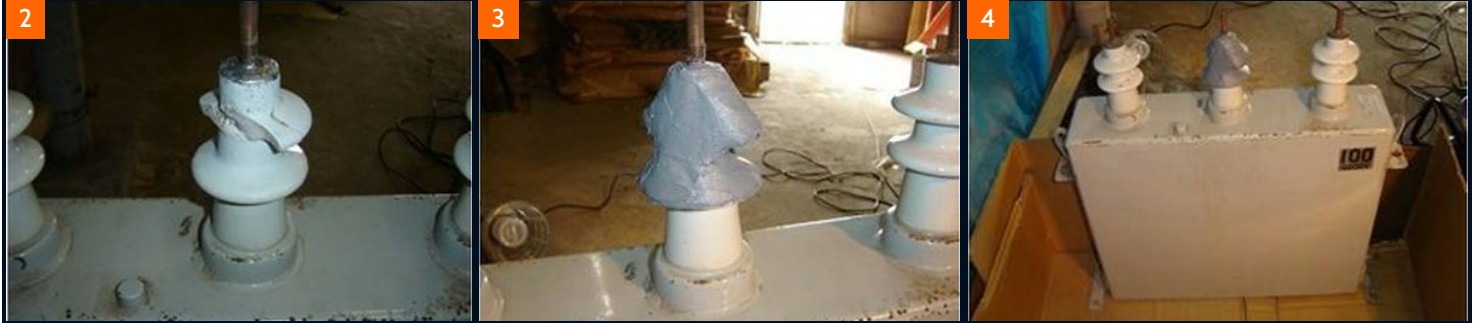
## PHOTOS

Leak caused by insulator damage. PCBs are extreme environmental pollutants now widely banned. Disposal can only be through specialist waste handlers. this leak was preventing safe disposal of the transformer.

1. The broken and leaking insulator
2. Surface preparation completed
3. Belzona 1161 applied
4. Application completed

Application carried out in accordance with modified Belzona Know-How System Leaflet VPF-11a. Belzona® 1161 was applied at 3-4 mm thickness onto the broken insulator. Cure was accelerated by using heat lamps.

The customer wanted to dispose of the condenser but this request was refused by a waste disposal firm as the equipment would cause environmental contamination by PCB. The Belzona repair was completed quickly allowing disposal to safely continue without risk of polluting the environment.
