# BELZONA SEALS SF6 LEAKS ON CIRCUIT BREAKER

ID: 1486

Bushing on 330kV circuit breaker.

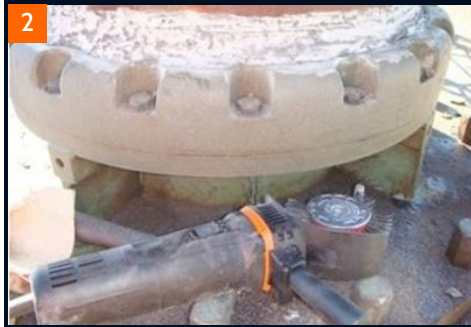
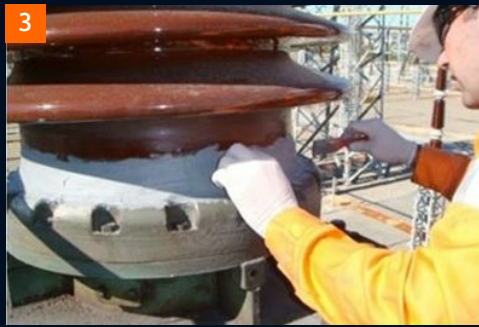
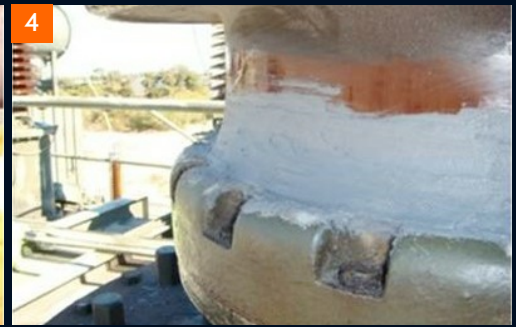
SF6 gas leaks through porcelain bushing seal

1. Original unsuccessful repair (still leaking)
2. Prepared area using the MBX Bristle blaster
3. Applying the Belzona 1161
4. Close up of the completed repair

Application was carried out in accordance with Belzona Know-How System leaflet VPF-11a. An MBX Bristle Blaster was used to prepare the surface before application of Belzona® 1161 to seal the leak area.

Application was carried out in an impressively simple and quick manner and created a totally successful gas tight seal where previous repair attempts had failed.
