# TRANSFORMER FLANGE SEALED WITH BELZONA

ID: 1489

Oil leaks at the bolted flange joints connections

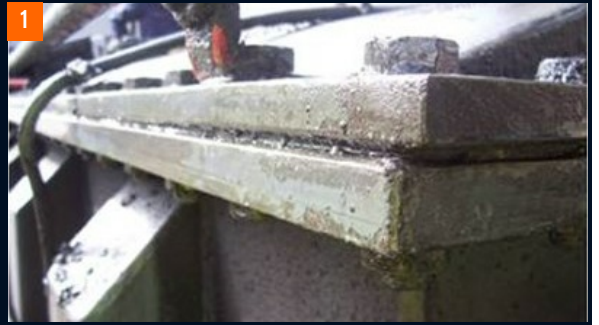
1. Leak area
2. MBX Bristle Blaster used for surface preparation
3. Belzona 9341 and Belzona 1161 applied to the flange joint
4. Application completed
