# PROTECTION OF BOILER FEED PUMPS WITH BELZONA 1391

ID: 149

## PROBLEM

Erosion on the impellers and casing.

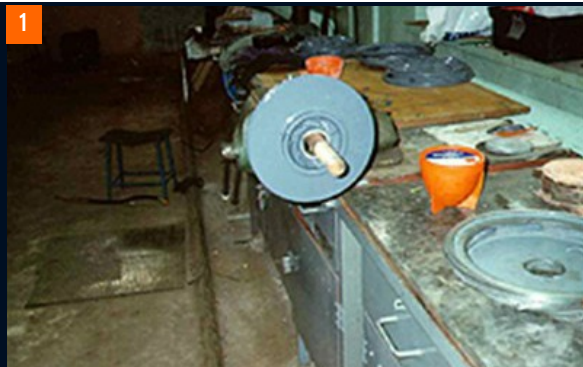
1. Application underway on one of the impellers.
2. Application complete.
3. Pump in service

Application carried out in accordance with Belzona Know-How system CEP-3.

A total of five pumps have now been coated and original pump is still performing satisfactory after four years in service.
