# BELZONA REPAIRS LIVE LEAK ON TRANSFORMER

ID: 1490

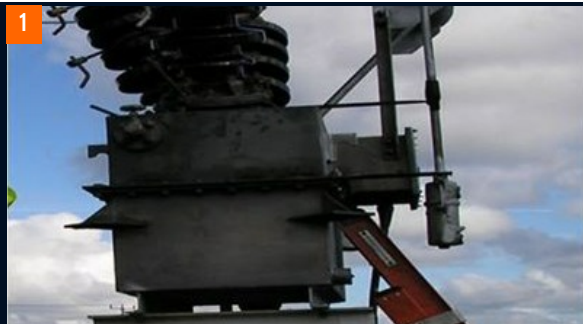
Oil leak causing environmental contamination.

Pipework on oil filled transformer.

1. Leak area
2. Leak stopped with Belzona 1291
3. Application completed with Belzona 1161

Application was carried in accordance with Belzona Know-How System leaflet VPF-11a. Belzona® 1291 used to firstly seal the live leak. The pipework was then encapsulated to prevent further leakage.
