# BELZONA SEALS LEAKING OIL PUMP

ID: 1493

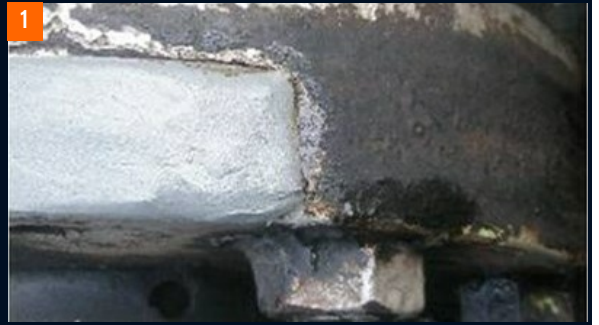
Oil was leaking from several parts of mechanical seal flanges.

1. Seal area before application
2. Surface preparation completed
3. Application of Belzona 1221
4. Application completed

Application was carried out in accordance with a modified version of Belzona Know-How System Leaflet VPF-11a. Surface was prepared with an MBX Bristle Blaster and initial leaks were temporarily sealed with Belzona® 1221 before permanent sealing with Belzona® 1161.
