# BELZONA REPAIRS SEDIMENT COLLECTOR DRAIN PIPE

ID: 1494

Sediment removal equipment for Condenser water feed

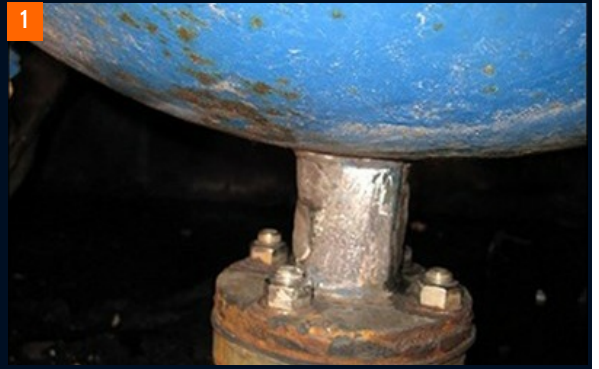
Industrial water was leaking from the corroded drain pipe.

1. Surface preparation completed
2. Leak stemmed with Belzona 1291
3. Belzona 1161 and Reinforcement Tape applied to complete repair

Application was carried out in accordance with Belzona Know-How System Leaflet VPF-11a. Belzona® 1291 was used to stem the live leak. Once no leaking was ensured, Belzona® 1161 plus Belzona® 9341 (Reinforcement Tape) was immediately used to overcoat the area to create a permanent repair.
