# BELZONA PROTECTS NEW HEAT EXCHANGER

ID: 1495

Protection against anticipated corrosion on new heat exchanger.

New chiller tube-sheet and end covers

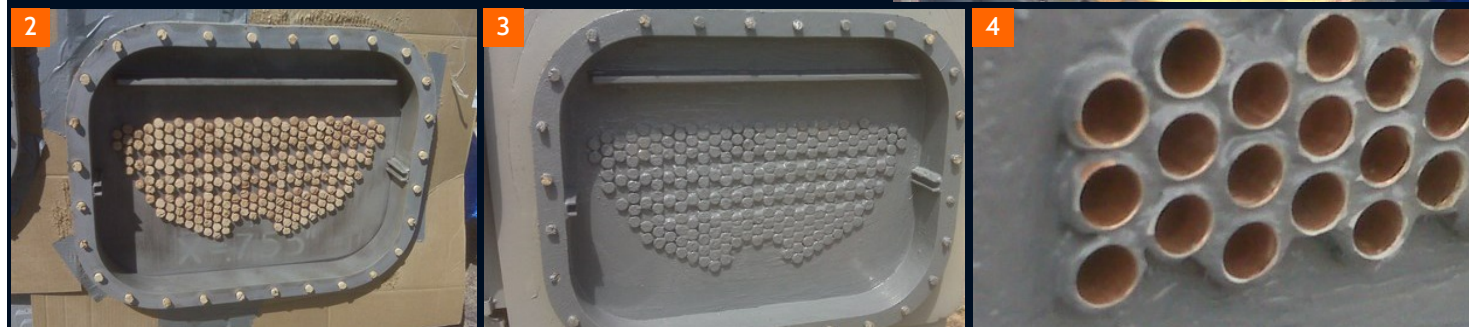
1. New chiller from factory
2. Blasted and corked tube-sheet
3. Belzona barrier system applied
4. Honed and cleaned tubes

Application was carried out in accordance with Belzona Know-How System Leaflet HEX-2. After blasting tube-sheet and end covers components were coated with Belzona® 1321.
