# LONG LASTING BELZONA ROOF PROTECTION

ID: 1496

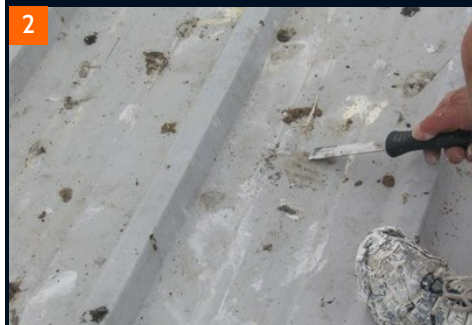
The original roof had been protected with Belzona® 3111 but new extension was suffering from leaks due to attack from bird litter and excrement which was chemically attacking the plastic coated steel sections. It is possible to see the corrosion on the extension, but not on the area that was originally coated with Belzona® 3111. Original application refurbished to provide further 15 years service life.

1. Original condition in 1990
2. Bird damage
3. Application revisited in 2010
4. Application re-visited in 2010

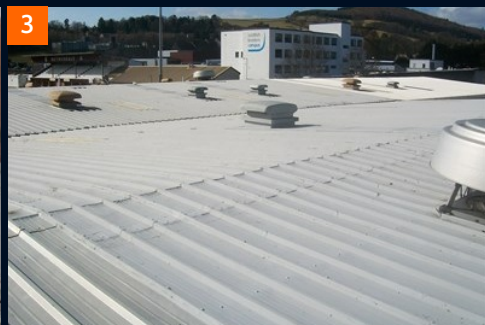
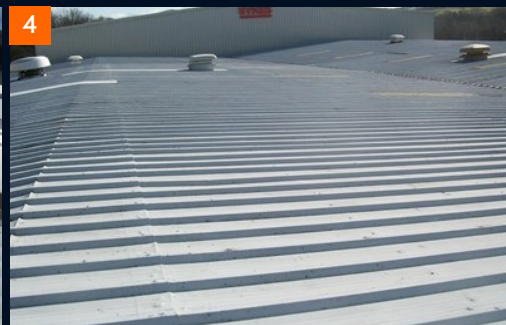
5 year inspection in 2010 shows both applications in excellent condition and client reported zero leaks after the harshest winters in 40 years.
