# BELZONA REFURBISHES RAW WATER STRAINER

Housing of raw water strainer.

Power Plant, Missouri

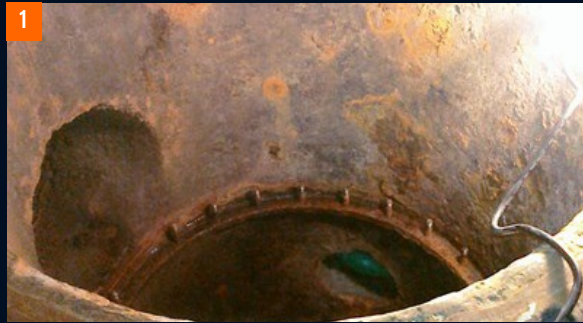
1. The strainer housing
2. Deep corrosion pitting clearly evident
3. Completed application

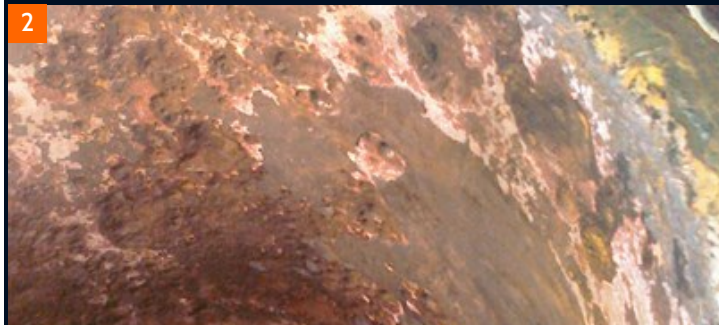
The existing coating had completely failed allowing severe pitting within the housing to occur. The customer was concerned not to allow further loss of wall thickness.

The application was carried out in accordance with Belzona Know-How System Leaflets VPF-1 & 2. The substrate was first prepared using needle guns to remove scale and remaining coating. This exposed more pitting that the customer could not previously see. The substrate was then grit blasted before Belzona® 1311 was used to fill in pitting and smooth out the entire surface. Finally two coats of Belzona® 1321 were applied.
