# BELZONA STOPS LEAK DRAIN PIPE AND HOT WELL PUMP

Leaking drain pipe and hot well pump at Water Treatment Plant

Drain pipe and hot well pump of a condenser

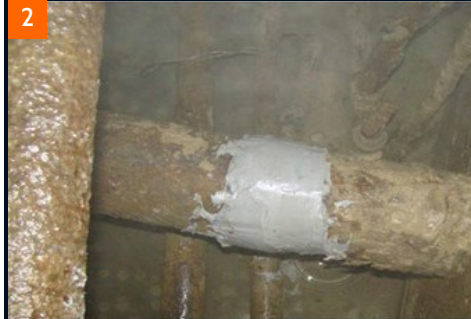
1. Overview of the large sized hole on drain pipe
2. To seal with Belzona 1161
3. Live leaks of hot well pump
4. Stop leak with Belzona 1291 and Belzona 1161

The application was carried out in accordance with a modified of Belzona Know-How System Leaflet HEX-9 and CEP-6 . First, Belzona 1291 was used to stop the leak, then Belzona 1161 along with Belzona 9341 covered the area.
