# BELZONA SEALS GASOLINE STORAGE TANK

A large gasoline storage tank

Petrochemical plant, Ontario, Canada

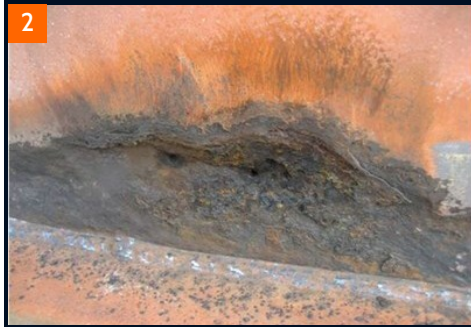
Water was collecting on this large reinforcement seam causing extensive corrosion.

1. Large corrosion area
2. Severity of corrosion clearly evident
3. Use of crane lift to access repair area
4. Completed Application
