# BELZONA FOR A CONCRETE COOLING TOWER BASIN

ID: 15

A concrete the cooling tower basin

Nuclear Power Plant in the Northeast, U.S.A.

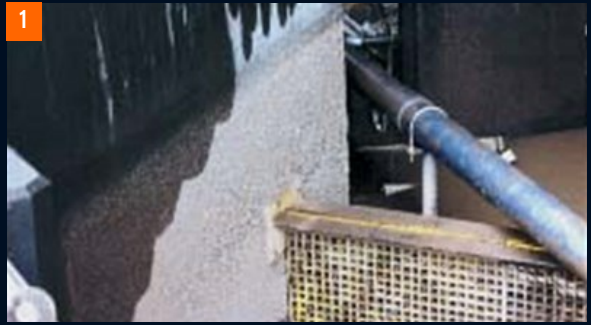
Sulfuric acid is injected into the cooling water to stop M.I.C. (microbiological induced corrosion). This severely damaged the concrete due to chemical attack and erosion three to four inches deep.

1. The damaged area.
2. Close-up view of severe erosion, the application of product ready to commence.
3. The completed repair, cooling tower basin in operation.
