# BELZONA PROTECTION ON RIVER BARRAGE

ID: 150

Flood defence barrage on tidal river

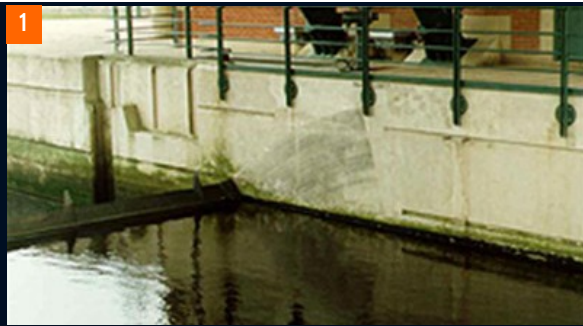
The rubber seals on the moving gates were being damaged by the concrete walls when the barrage was raised and lowered.

1. The abrasion from the rubber seals is clearly evident on the concrete
2. The completed application
3. The barrage in action
