# BELZONA TRUNNION BEARING HOUSING REPAIR SAVES MONEY

ID: 1503

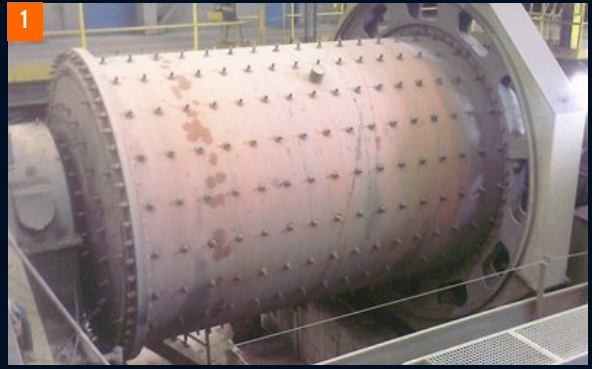
Overview of Rod Mill Close up of worn housing Applying the Belzona 1311 Final repair

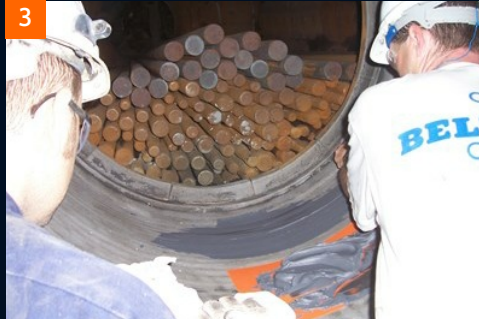
Bearing housing had allowed particulates to pass into housing and caused significant wear. Rod Mill downtime costs 20k per hour.

Rod Mill trunion bearing housing had significant wear and insufficient downtime for traditional weld/machining repair.

Application was carried out in accordance with Belzona Know-How System Leaflet MPT-2. Housing was heated with torch to sweat out oils. The substrate was then blasted to a 2-3 mil profile. Application of the Belzona® 1311 followed to rebuild housing back to OEM specification.
