# RUBBER PUMP LINERS REPAIRED WITH BELZONA

ID: 1505

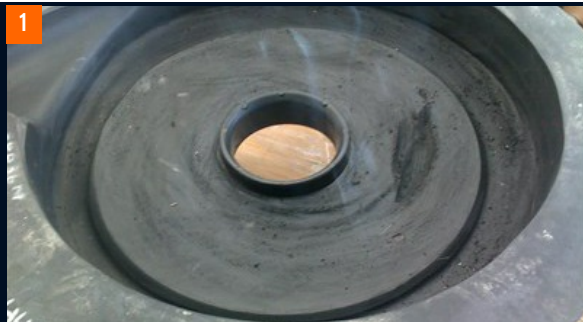
Slurry product destroys rubber liners in 3 weeks.

Damaged rubber liner Rubber liner being coated with Belzona 2111 Rubber liner after application of Belzona 2111

Application carried out in accordance with Belzona Know-How System Leaflet SHM-9. Belzona Roughing Brush used to prepare surface before Conditioning then rebuilding with Belzona® 2111.
