# BELZONA SEALS OIL LEAK AND PROTECTS THE ENVIRONMENT

ID: 1512

Access hatch on oil filled transformer.

Electrical Substation, UK

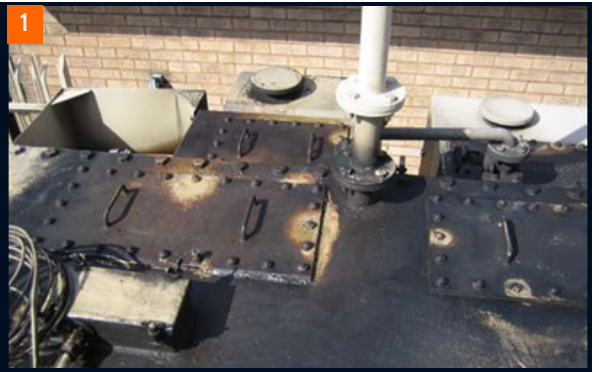
Transformer oil leaking from the top of the transformer onto the ground was heading towards a drain in the road, posing a serious environmental problem.

1. Leaking transformer
2. Surface preparation using MBX Bristle Blaster
3. Surface preparation completed and live leak sealed with Belzona 1291
4. Repair completed with application of Belzona 1161

Application was carried out in accordance with Belzona Know-How System Leaflet VPF-11a. Surface was cleaned and prepared with MBX Bristle Blaster. Belzona® 1291 was used to seal the visible leaks before the application of Belzona® 1161 and Belzona® 9311 (Reinforcing Sheet).
