# NOVEL REPLACEMENT OF GUTTER IN CHEMICAL PLANT USING BELZONA

ID: 1513

Gutter for collecting spills in a truck unloading area for Caustic soda and Hydrochloric acid.

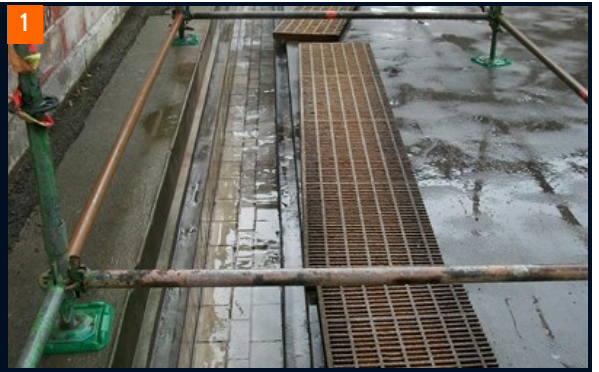
The original gutter was made of tiles which became soft and porous.

1. Damaged gutter
2. New steel gutter ready to be installed
3. Steel gutter grouted into place with Belzona 4151
4. Belzona 4311 applied to completely seal grout and surrounding concrete
