# BELZONA PROTECTS WATER TREATMENT PLANT FILTER

Filter for removing organic matter.

Water treatment plant, Girona, Spain

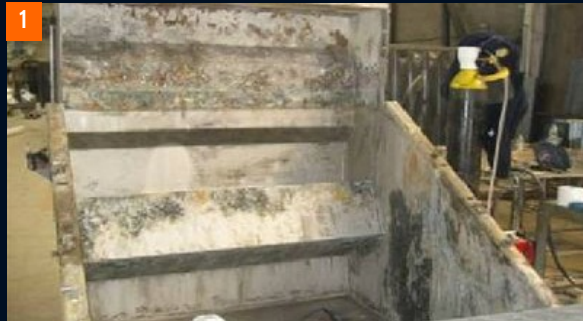
Severe corrosion of the stainless steel substrate due to the presence of Hydrogen Sulphide and Sulphuric acid. These are created by bacterial action in the organic matter.

1. Initial state of the sieve
2. Rebuilding with Belzona 1121
3. Application of the second coating of Belzona 4311
4. Finished unit
