# SAND FILTER LINING REPAIRED WITH BELZONA

ID: 1517

Ebonite lining in sand filter

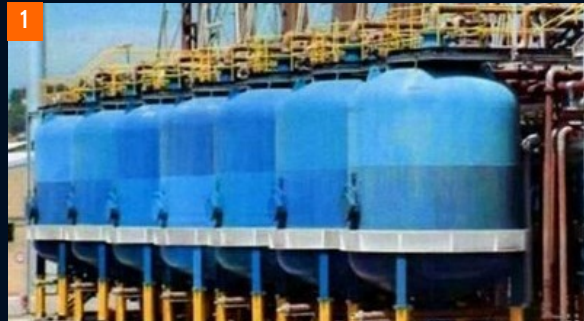
The ebonite lining showed severe degradation (cracks, grooves, gasket failure, adhesion problems) due to the corrosive action of the solution (brine 250 gr/Kg, active Cl<sub>2</sub> 0-20 ppm) at 65°C.

1. View of the filter from outside
2. Degraded area, cracked ebonite
3. Rebuilding with Belzona 1111
4. Ebonite coated with Belzona 5891

The application was carried out in accordance with Belzona Know-How System Leaflet TCC-3 & 5.

Thanks to the Belzona products, the filter was back in service after a rapid, easy and in situ repair. The cost of replacing ebonite would have been much higher. Belzona enabled a quick in-situ repair to be carried out, ensuring filter could returned to service with minimum disruption to production. Alternative (replacing ebonite) would have taken far longer and at far higher cost
