# SEALING TRANSFORMER OIL VALVES WITH BELZONA

ID: 1518

Oil valves feeding a transformer at substation.

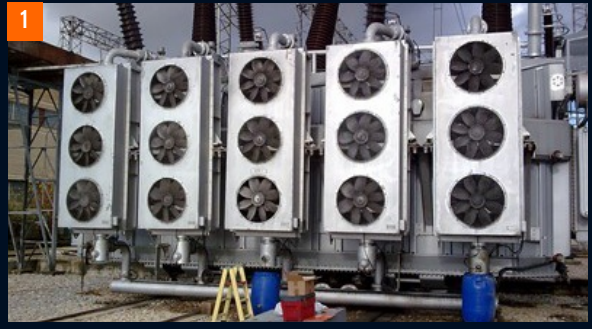
Valves were leaking oil due to a defective flange seal.

1. General view of the location for the unit
2. Cleaning the application area.
3. Final result after application of Belzona 1161
