# BELZONA SOLUTION TO ABRASION AT COAL MINE

ID: 1519

Transition pipe handling coal dust at 200°F.

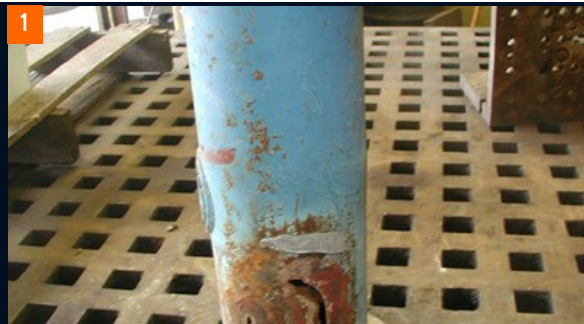
Excessive wear and costly replacement brought on by abrasion from coal dust. The coal chute and lateral fitting have an average operating temperature of 200°F. Due to excessive wear pipes were only lasting a few weeks before needing to be replaced. A cost effective alternative to replacement was being sought.

View of holed lateral fitting Close up of inside damage Interior view of completed application Outside view of completed application

Application was carried out using a modified version of Belzona Know-How System Leaflet SHM-13. The interior cavity was filled with Belzona® 1811 and a "hard back" was formed on the outside to give maximum thickness for abrasion resistance. Inside was lined with Belzona® 1391 overlaid with aluminum oxide. application was then post cured for maximum resistance.
