# BELZONA LEAK SEALING ON VALVES

ID: 152

Emergency water valves, 1.6m and 2.2m diameter, in dam.

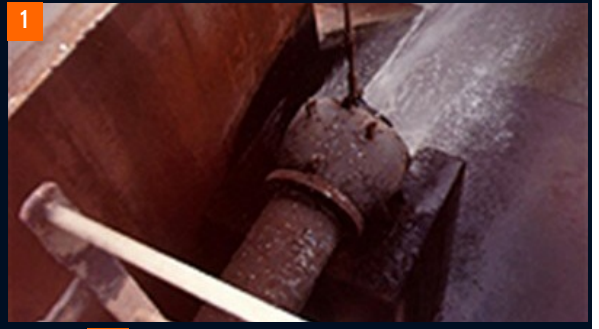
Erosion-corrosion leading to water leakage.

1. The degree of water leakage clearly evident from the 1.6m valve
2. Work underway on the 2.2m valve
3. Application completed
4. The two valves re-installed at the dam base
