# REPAIR AND PROTECTION OF HOSPITAL LAUNDRY FLOOR WITH BELZONA

ID: 1523

Uneven laundry floor of hospital

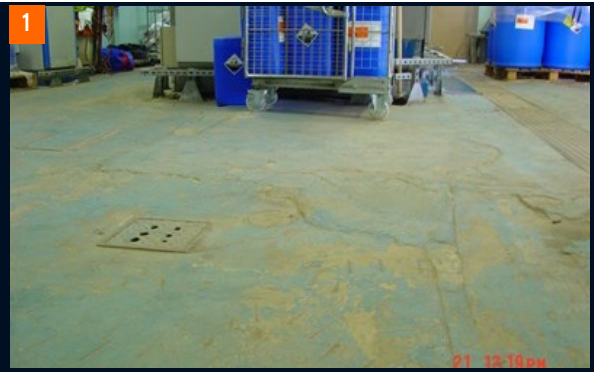
The laundry floor of this hospital was not level and water was gathering in the middle of the floor. They needed the floor to be re-levelled so that water ran to the drains. The floor also had to be safe from accidents.

Uneven, damaged laundry floor  
Application of Belzona 4131  
Application of Belzona 4131 Completed application

Application was carried out in accordance with Belzona Know-How System Leaflet FPA-1. Existing floor was cut out to create a fall and then screeded over with Belzona® 4131. This was then overcoated with Belzona® 5231.
