# DUCT SEALING WITH BELZONA 4211

ID: 153

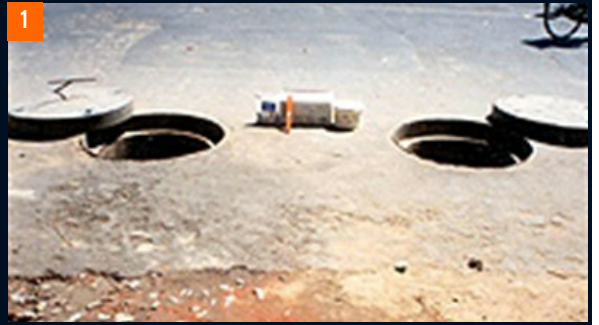
Water leakage into the chambers causing cable joints to be submerged and extensive disruptions to telephone lines. Problem is particularly great during the monsoon.

1. Access to the chambers
2. The cable connections
3. & 4. Application of Belzona 4211 underway
