# BELZONA REPAIRS TO SPALLED CONCRETE

Cast concrete perimeter roof detail

Art college in U.K.

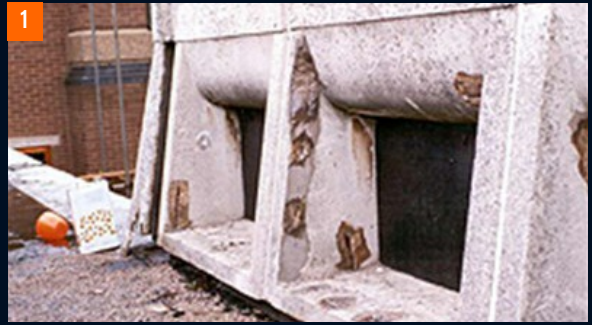
Carbonation of the concrete allowing corrosion of the steel reinforcing leading in turn to serious spalling of the concrete.

1. Some of the extensive spalling prepared and conditioned
2. Belzona 4141 applied to rebuild the spalled concrete
3. Completed application
