# BELZONA 3111 WEATHERPROOFS PROBLEM ROOF

ID: 155

Roof of multi-storey block of offices

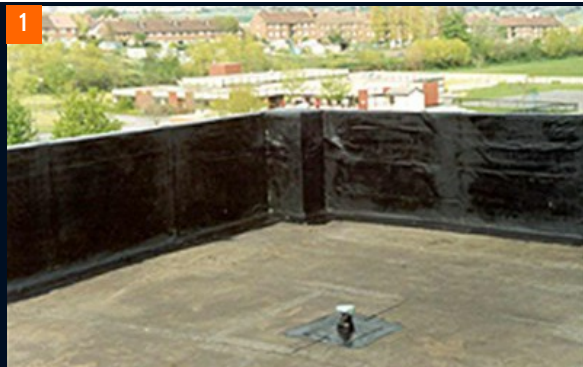
Deterioration of original felt finish had allowed water ingress into the roof deck. In particular the roof insulation had become saturated. Traditional repairs had not been successful.

1. The original roof surface with new breather vents installed
2. Application underway. Note detail application to flashings and parapet wall
3. Completed application

Application was carried out in accordance with Belzona System Leaflets RPA-6, RPA-8, and RPA-10. Breather vents were also installed to allow the insulation to dry out.
