# BELZONA BELT SWAT TEAM

ID: 156

Conveyor belt

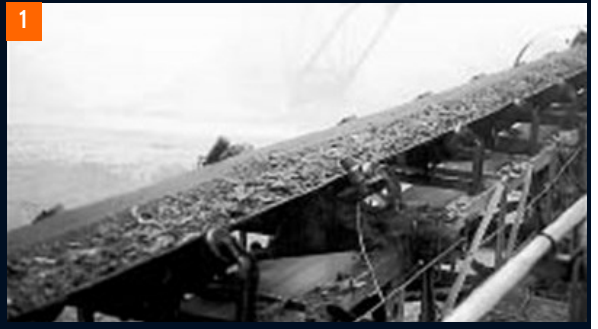
A small hole under belt tension is expected to get larger and debris was leaking through the belt.

1. Belt delivers bark to powerhouse, 24 hours a day, 7 days a week
2. Surface preparation completed using Belzona roughening brush, and Belzona 2911 (Q.D. Conditioner) is applied
3. Hole successfully patched by the happy crew (Belt Swat Team)!
