# BELZONA FOOD PROCESSING FLOOR

ID: 157

Food Processing Plant in Minnesota

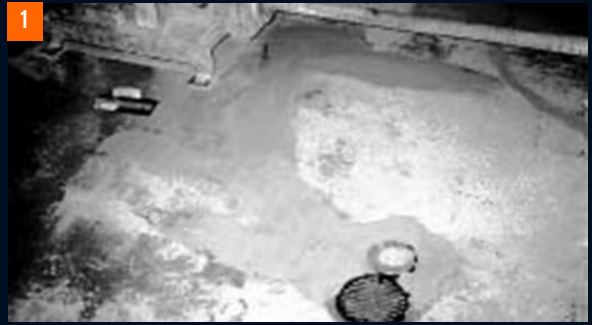
The floor was badly deteriorated from constant wear and washings.

1. Severely damaged areas patched with Belzona 4131
2. Application of slurry Belzona 4111/4151 system in progress
3. The completed application

Belzona 4131 (Magma Screed)
