# BELZONA REPAIRS EBONITE LINING IN ACID STORAGE TANK

ID: 1571

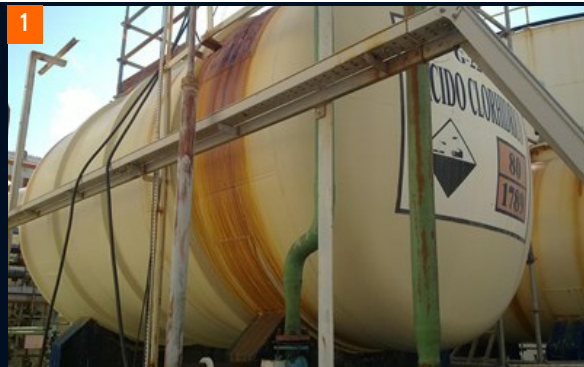
1. Outer view of the tank to be repaired
2. Damaged area of Ebonite
3. Local rebuilding of ebonite with Belzona 4301 after surface preparation
4. Ebonite coated with Belzona 4311

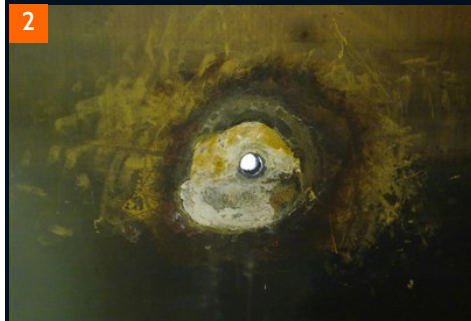
The Ebonite coating in a tank containing 26% Hydrochloric acid had localised damage (cracks, grooves, seam failures, adhesion problems) due to the acid contents of the tank.
