# NOZZLE IN ACID TANK PROTECTED WITH BELZONA INSERT

ID: 1572

Nozzle into Hydrochloric acid storage tank at Caustic soda producer

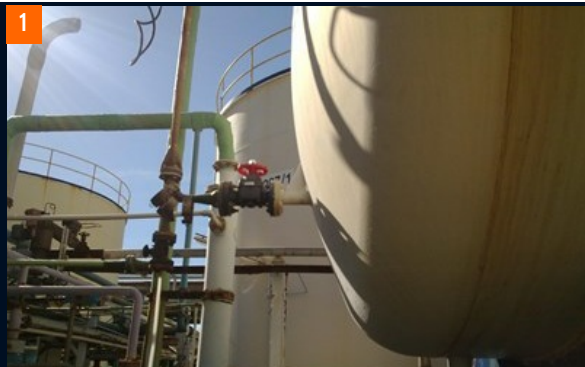
The interior of an ebonite lined nozzle handling 26% Hydrochloric acid had suffered damage.

1. Outer view of the tank and nozzle
2. Belzona 4301 Nozzle Insert being installed
3. Surrounding Ebonite rebuilt with Belzona 4301 to seal the insert
4. Insert sealed at the flange
