# BELZONA PROVEN PROTECTION FOR SEDIMENTATION TANK

ID: 1574

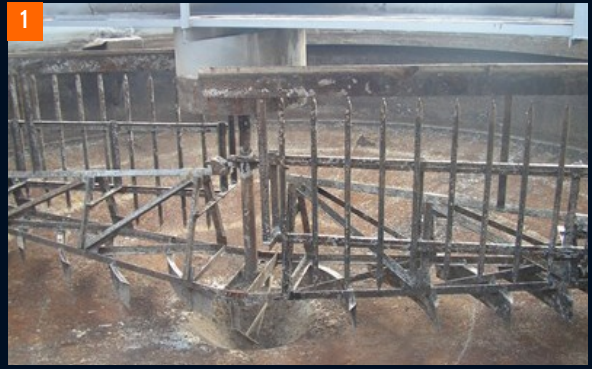
The tanks suffer from severe corrosion.

1. Tank showing severe corrosion
2. Grit-blasting the tank
3. Setting up the spray equipment
4. Tank after the application
