# BELZONA FLOOR REPAIRS IN CIDER FACTORY

ID: 1575

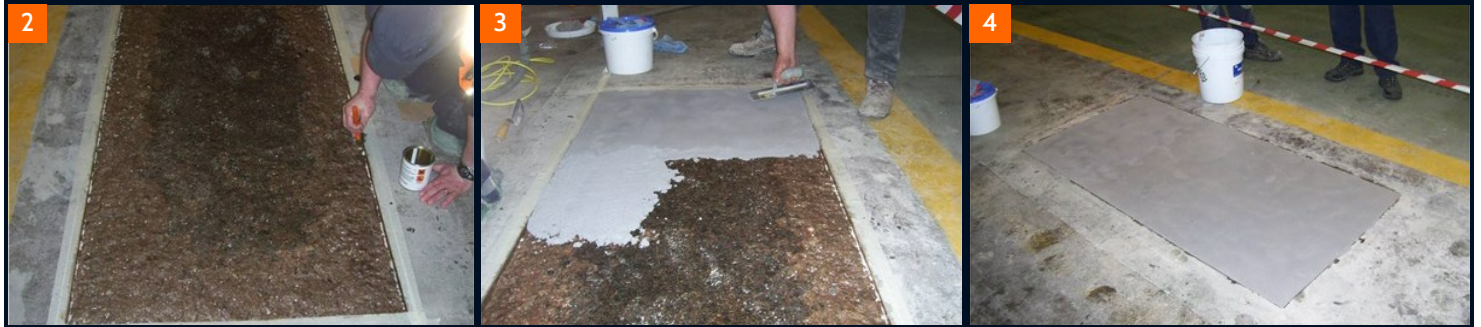
## PHOTOS

Lorry trailers park here and the stabilisers when lowered damage the floor area after 6-8 months.

1. Preparation of damaged area
2. Application of Conditioner
3. Applying Belzona 4131
4. Completed Application

Application was carried out in accordance with Belzona Know-How System Leaflet FPA-1.

The repairing and protection of the floor in these localised areas with Belzona® 4131 resists both impact and abrasion thus extending the life of the floor area leading to reduced maintenance. The customer was very pleased with the results and this job has lead to several other applications being undertaken in the plant.
