# PROVEN BELZONA SUCCESS ON CONDENSATE TANK PROTECTION

ID: 1576

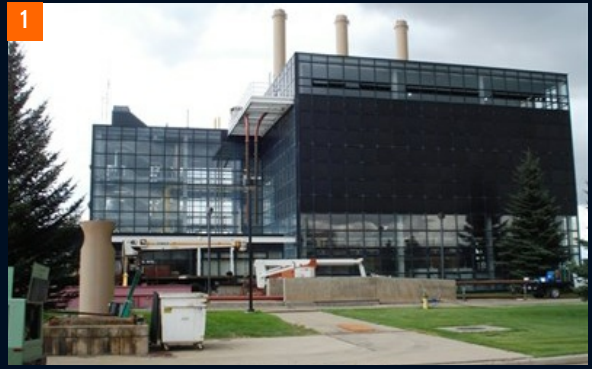
1. Universities hot water plant
2. Original Belzona coating application
3. Touch-ups on tank walls
4. Touch-ups On tank floor

Original Belzona application was carried out in 2008. In August 2010 the application was inspected and only minor touch ups were required where underlying concrete had cracked.
