# BELZONA SUPERWRAP SEALS WEEPING STORAGE TANK

ID: 1577

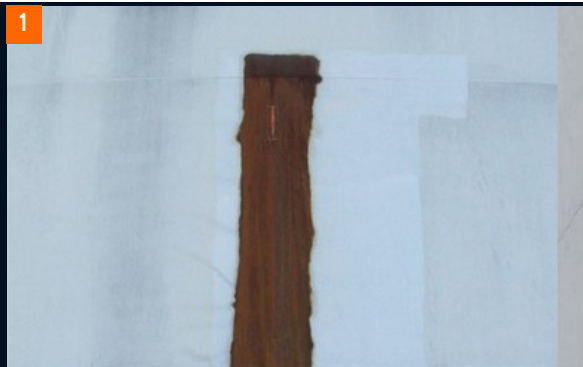
Vertical weld was found to be very porous and fuel oil was weeping from a 2 mm through wall defect. No corrosion or thin wall area was detected. Defect was located at 30 feet from the ground level.

1. Damaged area
2. Area prepared by abrasive blasting
3. Belzona SuperWrap application
4. Belzona SuperWrap repair inspected and painted over
