# BELZONA PROVIDES LONG TERM SOLUTION IN COOL ROOMS

ID: 1578

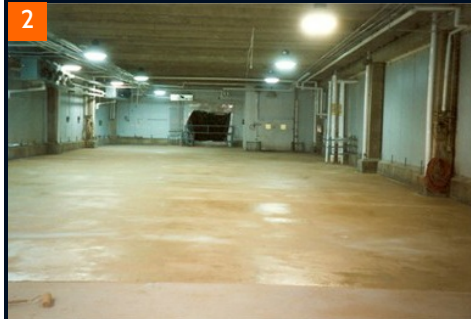
3

After 14 years the floor was still water proof and without any leaks. Some scratches were present due to metal wheeled fork lifts but no water penetration. Small areas were touched up. Customer was very happy with longevity of the application.

1. Second Floor Cooler
2. After Original Application
3. Floor After 14 Years
4. Only Small Damage Present
