# BELZONA BACKHOE SWING ARM REPAIR AT EQUIPMENT RENTAL COMPANY

ID: 158

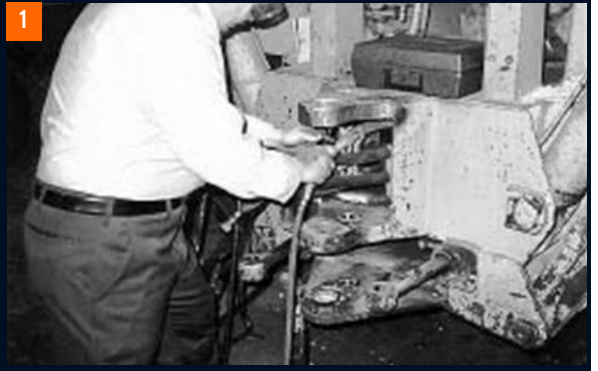
## PHOTOS

All three swing arm bushings had been destroyed and the metal of the bushing bores was severely worn.

1. Preparation in progress
2. Bushings installed

The application was carried out in accordance with Belzona Know-How Leaflet MPT-8.

Typically, rental units tend to get abused. The previous year, a similar repair was done for this customer on another unit damaged when the machine was being transported on the highway. The swing arm was left up too high and hit an overpass at 55 mph. Despite numerous repairs over the years, the swing arm bushing fits have never had to be redone as of January, 1994. About \$30 of Belzona® 1111 Super Metal was used by one man in 1/2 hour to do this fix. A conventional repair was quoted at \$7,500.
