# EXTERNAL TANK CORROSION PROTECTION WITH BELZONA

ID: 1580

Tank walls were suffering from external corrosion

Oil storage tank

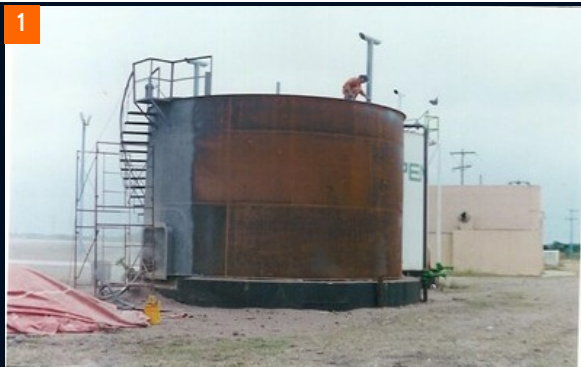
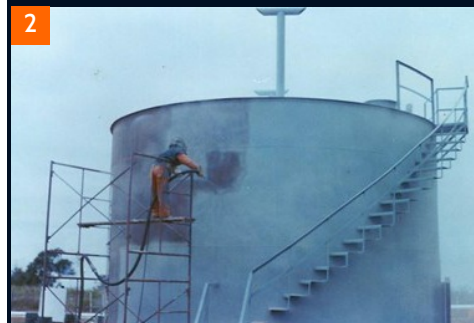
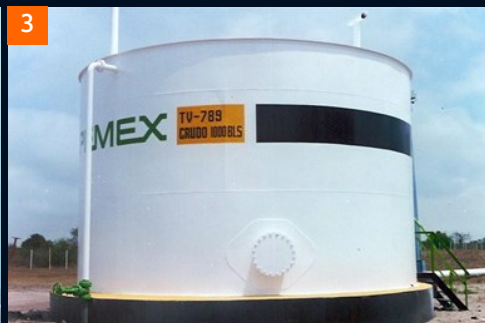
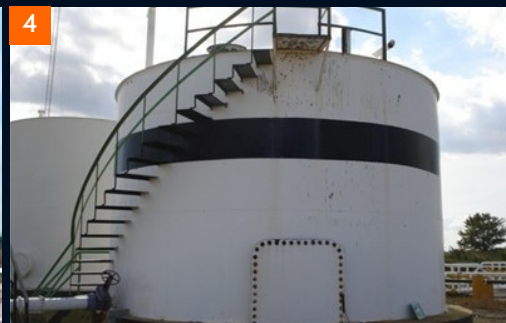
## PHOTOS

Surface preparation Applying Belzona 6111 Application completed Tank ten years after application

The application was carried out in accordance with Belzona Know-How System Leaflet TCC-5.

10 years after the application, the inspection showed the Belzona product was in perfect condition. The Belzona application saved the customer an estimated US\$ 39,500 through reduced maintenance costs.
