# BELZONA PROTECTS NEW FLASH DRUM

ID: 1581

New flash drum for the amine plant.

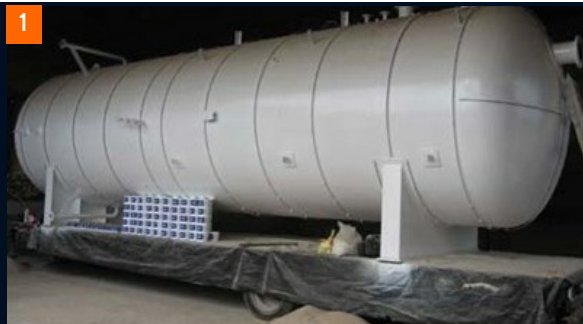
Flash drum prior to commencement of application Surface Preparation by abrasive blast cleaning Application of Belzona 1391 underway Photo taken during inspection at 2010 shutdown
