# BELZONA REPAIRS UNDERWATER PIPE ON OFFSHORE PLATFORM

ID: 1582

Sump pipe on oil and gas platform

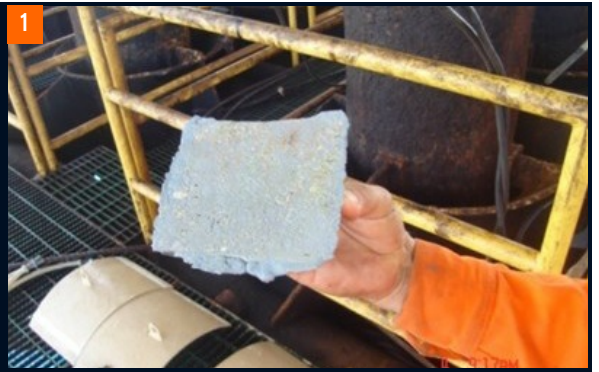
1. Adhesion test being carried out with plates coated with Belzona 5831 prior to application
2. Testing Belzona 1161 on edges of plate under immersed conditions
3. Application being carried out by divers under water

Application was carried out using a modified version of Belzona Know-How System Leaflet VPF-11a. Surface was cleaned in accordance with ISO 8501-1 St2/3 using pneumatic sander. Prior to commencement of the application several plates were coated with Belzona® 5831 for future corrosion protection. Plates bonded in place by diver using Belzona® 1161. Clamps were used to hold plates in place during curing process.
