# BELZONA CONTRIBUTES TO PUMP EFFICIENCY PROGRAMME IN STEEL PLANT

Continuous casting plant of a steelmill has over 60 pumps used to provide cooling water to casting rolls, burner injectors of blast furnace and other different areas. 12 pumps were identified for coating and efficiency monitoring.

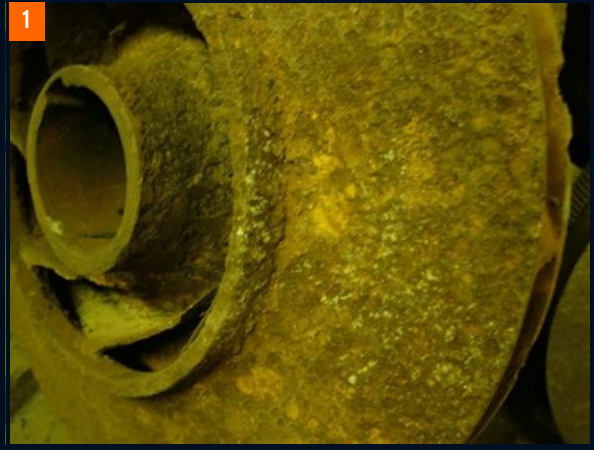
Damage due to erosion and corrosion caused high efficiency loss. The 12 selected pumps are 15 years old. But there are another 60 pumps 30-36 years old which have certainly higher efficiency loss as the tested ones.

1. Pump surface before coating
2. Grit blasted impeller
3. Coated parts
4. Coated housing
