# BELZONA GETS COMPRESSOR BACK TO SERVICE IN HOURS

ID: 1584

CO<sub>2</sub> compressor, a key equipment in producing Amide fertilizer.

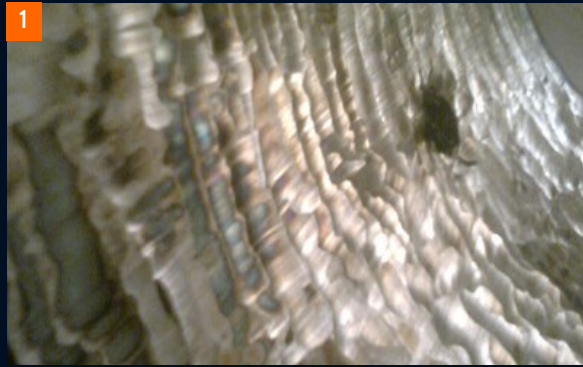
Worn compressors are unable to supply the necessary amount of CO<sub>2</sub> into the production line.

1. Worn surface
2. Injecting Belzona 1321
3. Smooth finished surface after removing former
4. Finished compressor housing

Application is carried out in accordance with a modified version of Belzona Know-How System Leaflet PDP-2 and MPT-2. Belzona® 1321 is injected into a stainless steel form prepared to match the required bore. It is treated with Belzona® 9411 (Release Agent) to aid removal once the Belzona® 1321 has cured.
