# BELZONA RESTORES HYGIENE LEVELS IN SWEET/CANDY MANUFACTURER

ID: 1585

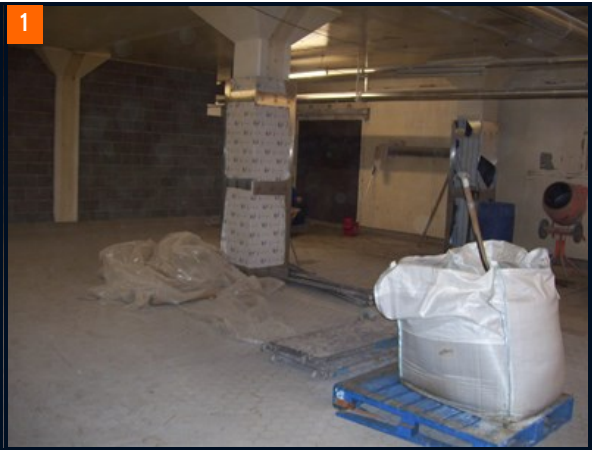
New Kitchen was being installed and required repairs to walls and a coating to be applied to ensure hygiene levels were met.

1. Kitchen area to be coated
2. Belzona 5911 (Ceramic Conditioner) being applied
3. Completed wall coating
4. Wall coating revisited 12 years later

Application was carried out in accordance with Belzona Know-How System Leaflets WPA-2 & 4. The damaged areas were repaired using Belzona 4141 to ensure smooth surface for application of the Belzona 5111 System.

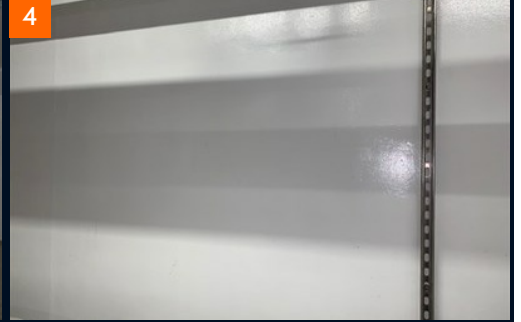
Initially 1/3 of the kitchen areas were refurbished with the Belzona System. Since then the customer has been so pleased with the results that they plan to complete the rest of the kitchen areas. 12 years later, the coating is still in great condition proving a highly decorative, non-toxic wall surface which is easy to clean.
