# BELZONA TACKLES SEVERE CUI ON COLUMN

ID: 1586

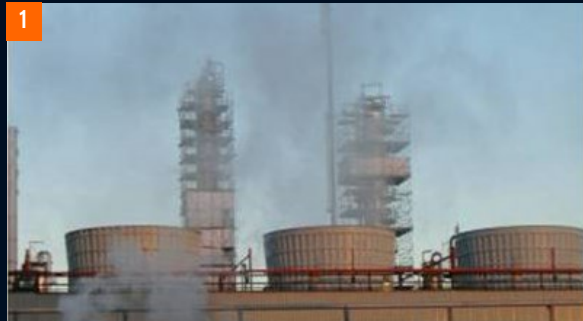
1. General view of refinery
2. Application area after grit-blasting
3. Completed application
4. Completed application

Application was carried out in accordance with Belzona Know-How System Leaflet TCC-5. The Belzona® 5851 was hand applied as a two coat system to grit blasted 8m sections of the column that were then re lagged before moving on to the next section. vessel remained in service throughout the application.

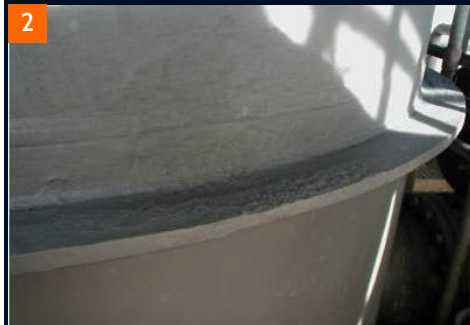
Water ingress into the lagging caused corrosion which was accelerated by the elevated temperatures of the column which operated up to 185°C.
