# BELZONA UPGRADE TO FLOOR IN CHOCOLATE FACTORY

ID: 1588

Floor in canteen wash area.

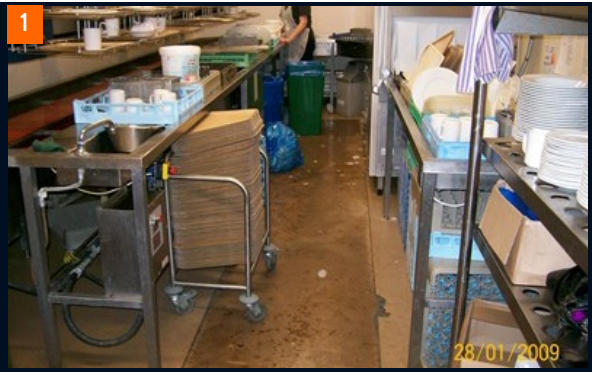
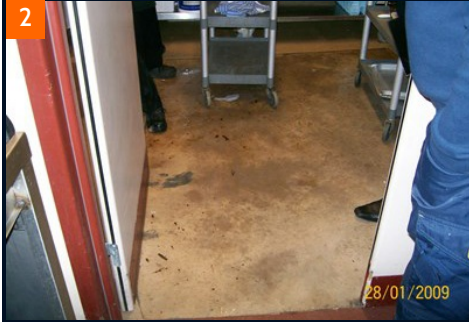
The existing coating had begun to deteriorate and sections of the main walk area had been removed exposing the concrete substrate beneath. This was not only unsightly; it also represented a health risk as staff were unable to clean the floor area adequately as food particles become trapped in the surface. The area also presented a considerable slip risk.

1. Floor Areas to be Repaired
2. Floor Areas to be Repaired
3. Completed Floor Application
4. Completed Floor Application

The remainder of the original floor coating was uplifted and the whole concrete floor area Application was carried out in accordance with Belzona Know-How System Leaflet FPA-3.

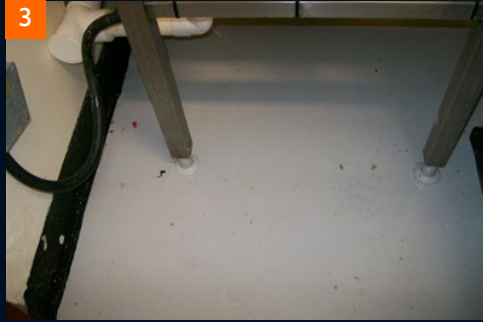
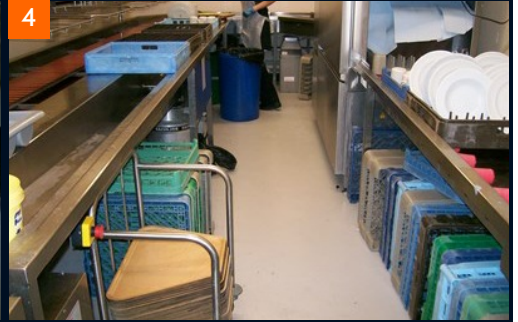
The clients requirements and expectations have been met in full and they are very pleased with the results. the floor provides a hygienic surface that cannot harbour bacteria and also provides a slip resistant surface for the staff.
