# BELZONA REPAIRS AND WATERPROOFS OFFSHORE ROOF

Corroded living quarters roof on offshore platform.

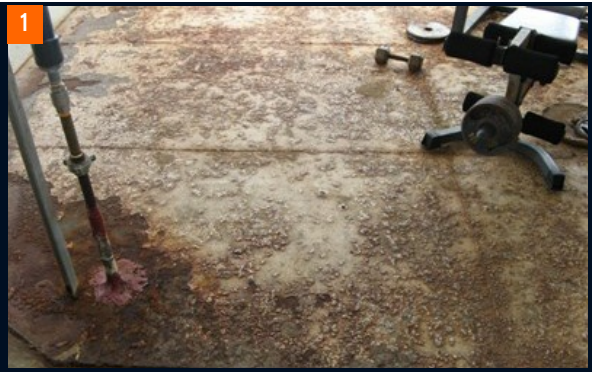
Customer seeking roof repair and installation of waterproofing system without disrupting oil and gas production. Metal roof had severe corrosion resulting in thin wall and some holes through the plates.

1. Roof showing severe corrosion
2. Roof after grit blasting
3. Roof after repairs and first coat Belzona 3111
4. Roof after completion

Application was carried out in accordance with Belzona System Leaflets RPA-1, RPA-6 and TCC-1. Belzona 1121 was used to bond doubler plates over thinned and holed areas before applying a fully reinforced Belzona 3111 System over the entire area.
