# BELZONA PROOFING BOX FLOOR FOR SUPERMARKET

ID: 159

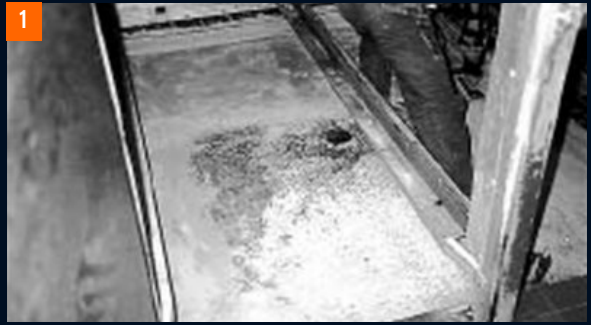
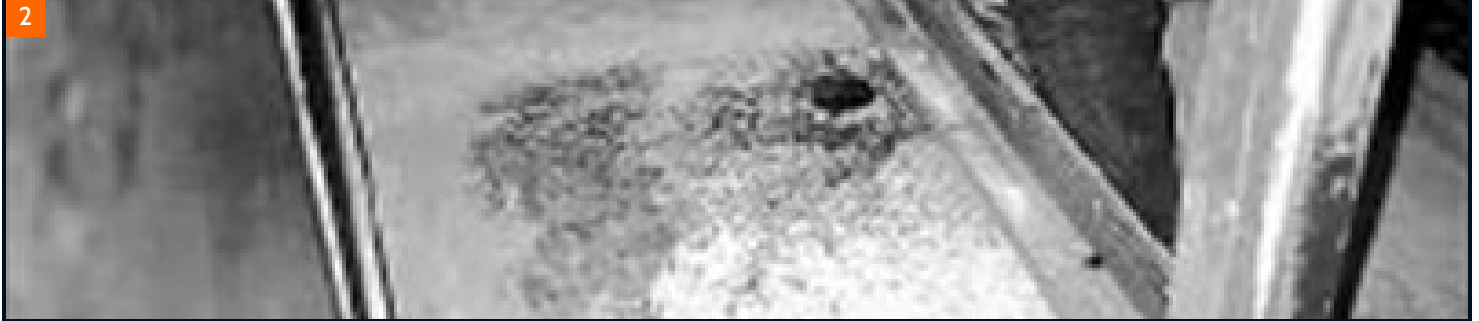
## PHOTOS

The proofing boxes in the bakeries is where bakery products are put to cause the dough to rise. Temperature is held at 100°F. Repairs required a U.S.D.A. approved food safe product.

1. Partial application showing damaged concrete
2. Completed application of proofing box

The application was carried out in accordance with Belzona Know-How Leaflet FPA-1.

These bakeries run 24 hours a day. One reason Belzona® 4111 was chosen is it has no offensive odor. The repair started around noon and finished by 2:00 p.m., allowing plenty of time for the Belzona® 4111 to cure before the next scheduled bakery shift at 2:00 a.m. the next morning. No odor was detected at 2:00 a.m. A total of 12 store proofing boxes were done.
