# COLD PLATE BONDING WITH BELZONA RESTORES SUMP TANK

ID: 1590

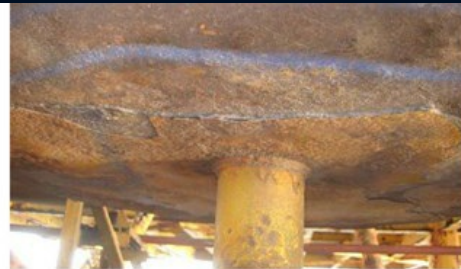
1

Exposure to the elements and oil & gas process systems caused severe corrosion to exterior of sump tank bottom. Damage resulted in thin wall and through hole areas.

1. Corroded tank bottom 2. Sump bottom after blasting 3. New bottom jacked into place 4. Bonding completed
