# BELZONA HELPS PROTECT OFFSHORE PLATFORM LEGS AT WATERLINE

ID: 1591

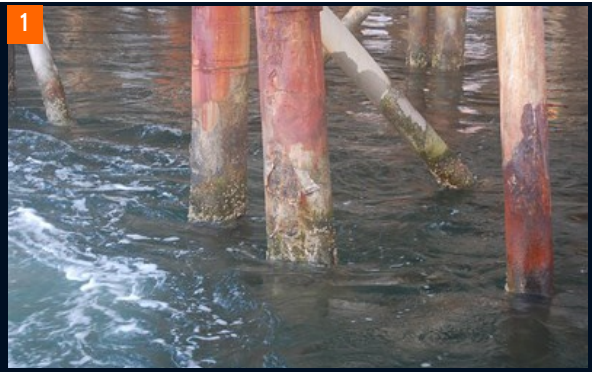
Due to corrosion and impact damage platform legs were at risk of losing structural integrity. Client wanted to terminate damage to avoid further deterioration. Customer had welded top and sides of halfwrap without welding bottom, due to water/wave action. Corrosion had actually accelerated between the leg and halfwrap.

Platform legs damaged by corrosion and impact from service/crew boats at the waterline.

1. Platform leg showing typical damage
2. Halfwrap being installed
3. Application of Belzona 1161 to seal bottom seam
4. Injection of Belzona 5831 to fill cavity between leg and halfwrap

Application was carried out in accordance with modified Belzona Know-How System Leaflet SOS-8. Belzona 1161 was used to seal the bottom of split shells, and Belzona 5831 was then injected to fill cavity between platform leg and steel wrap.
