# BELZONA REPAIRS TRIP HAZARDS AT CIDER FACTORY

ID: 1593

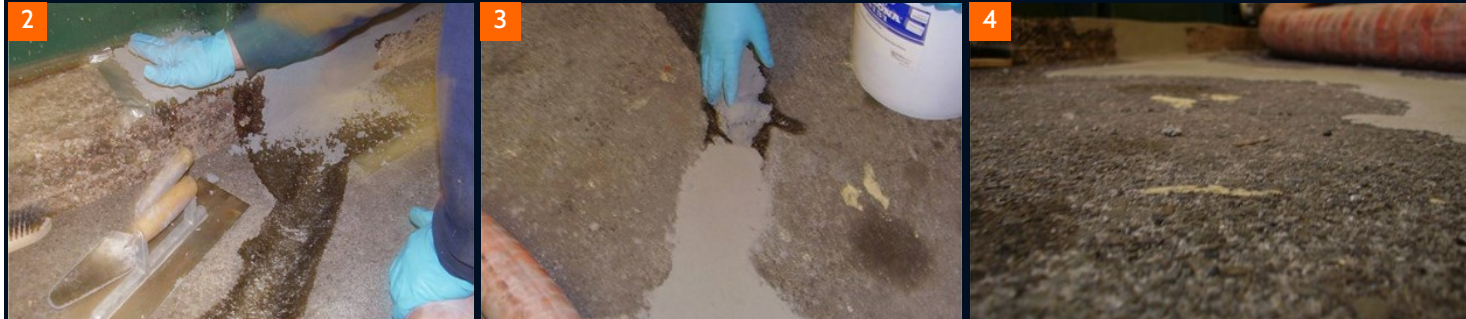
There are access lids at the base of the tank which are held in place with bolts and secured by a gasket to the base of the lid. However, these areas can be prone to leaking as the aggressive cider juice drips and eats away at the gasket and then attacks the concrete floor at the base of the tank, as you can see from the pictures. Eventually, this creates a gulley which can be a serious trip hazard.

1. The grooves in the floor
2. Applying the Belzona 4131 by hand
3. Filling in the gaps by hand
4. The old and new floor, viewed at ground level

The areas requiring repair were washed down. As per the IFU once dry the areas were coated with Belzona® 4911 followed by Belzona® 4131. We discovered that the process worked best when applied by (gloved) hand whilst holding the trowel against the concrete edge and sliding the trowel away once the Belzona® 4131 was in the void.

After a first inspection over a month later, the surrounding area was discolouring and graining but the reclaimed areas were standing up well to exposure to the raw cider. As a result, the client now wishes to coat the whole area once the application has proved itself, as well as the other eight 'planetary suites'.
